# EMERGENCY ACTION PLAN

FAWN LAKE DAM  
SPOTSYLVANIA COUNTY, VIRGINIA

Inventory Number: 17709

April 2017

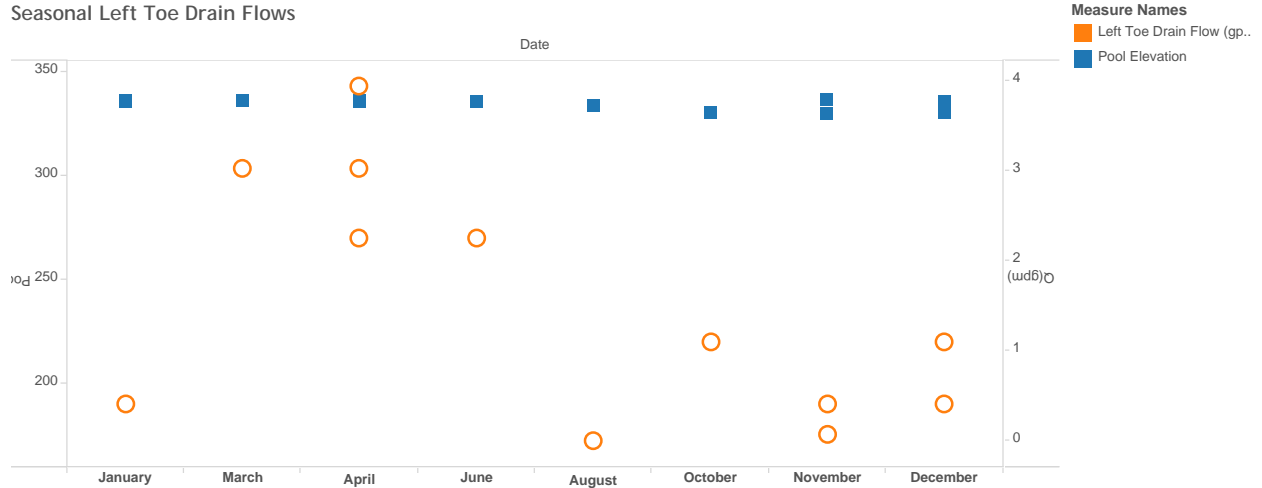
Seasonal Left Toe Drain Flows

There is a weir box located to the left the principal spillway that measures the quantity of flow from the left toe drain and lake pool elevations. Flows outside these ranges are a potential indicated of a developing problem and should be addressed in a timely manner.
