**FAWN LAKE
INUNDATION ZONES**

Dewberry

Nov. 15, 2010
Rev. April 6, 2011

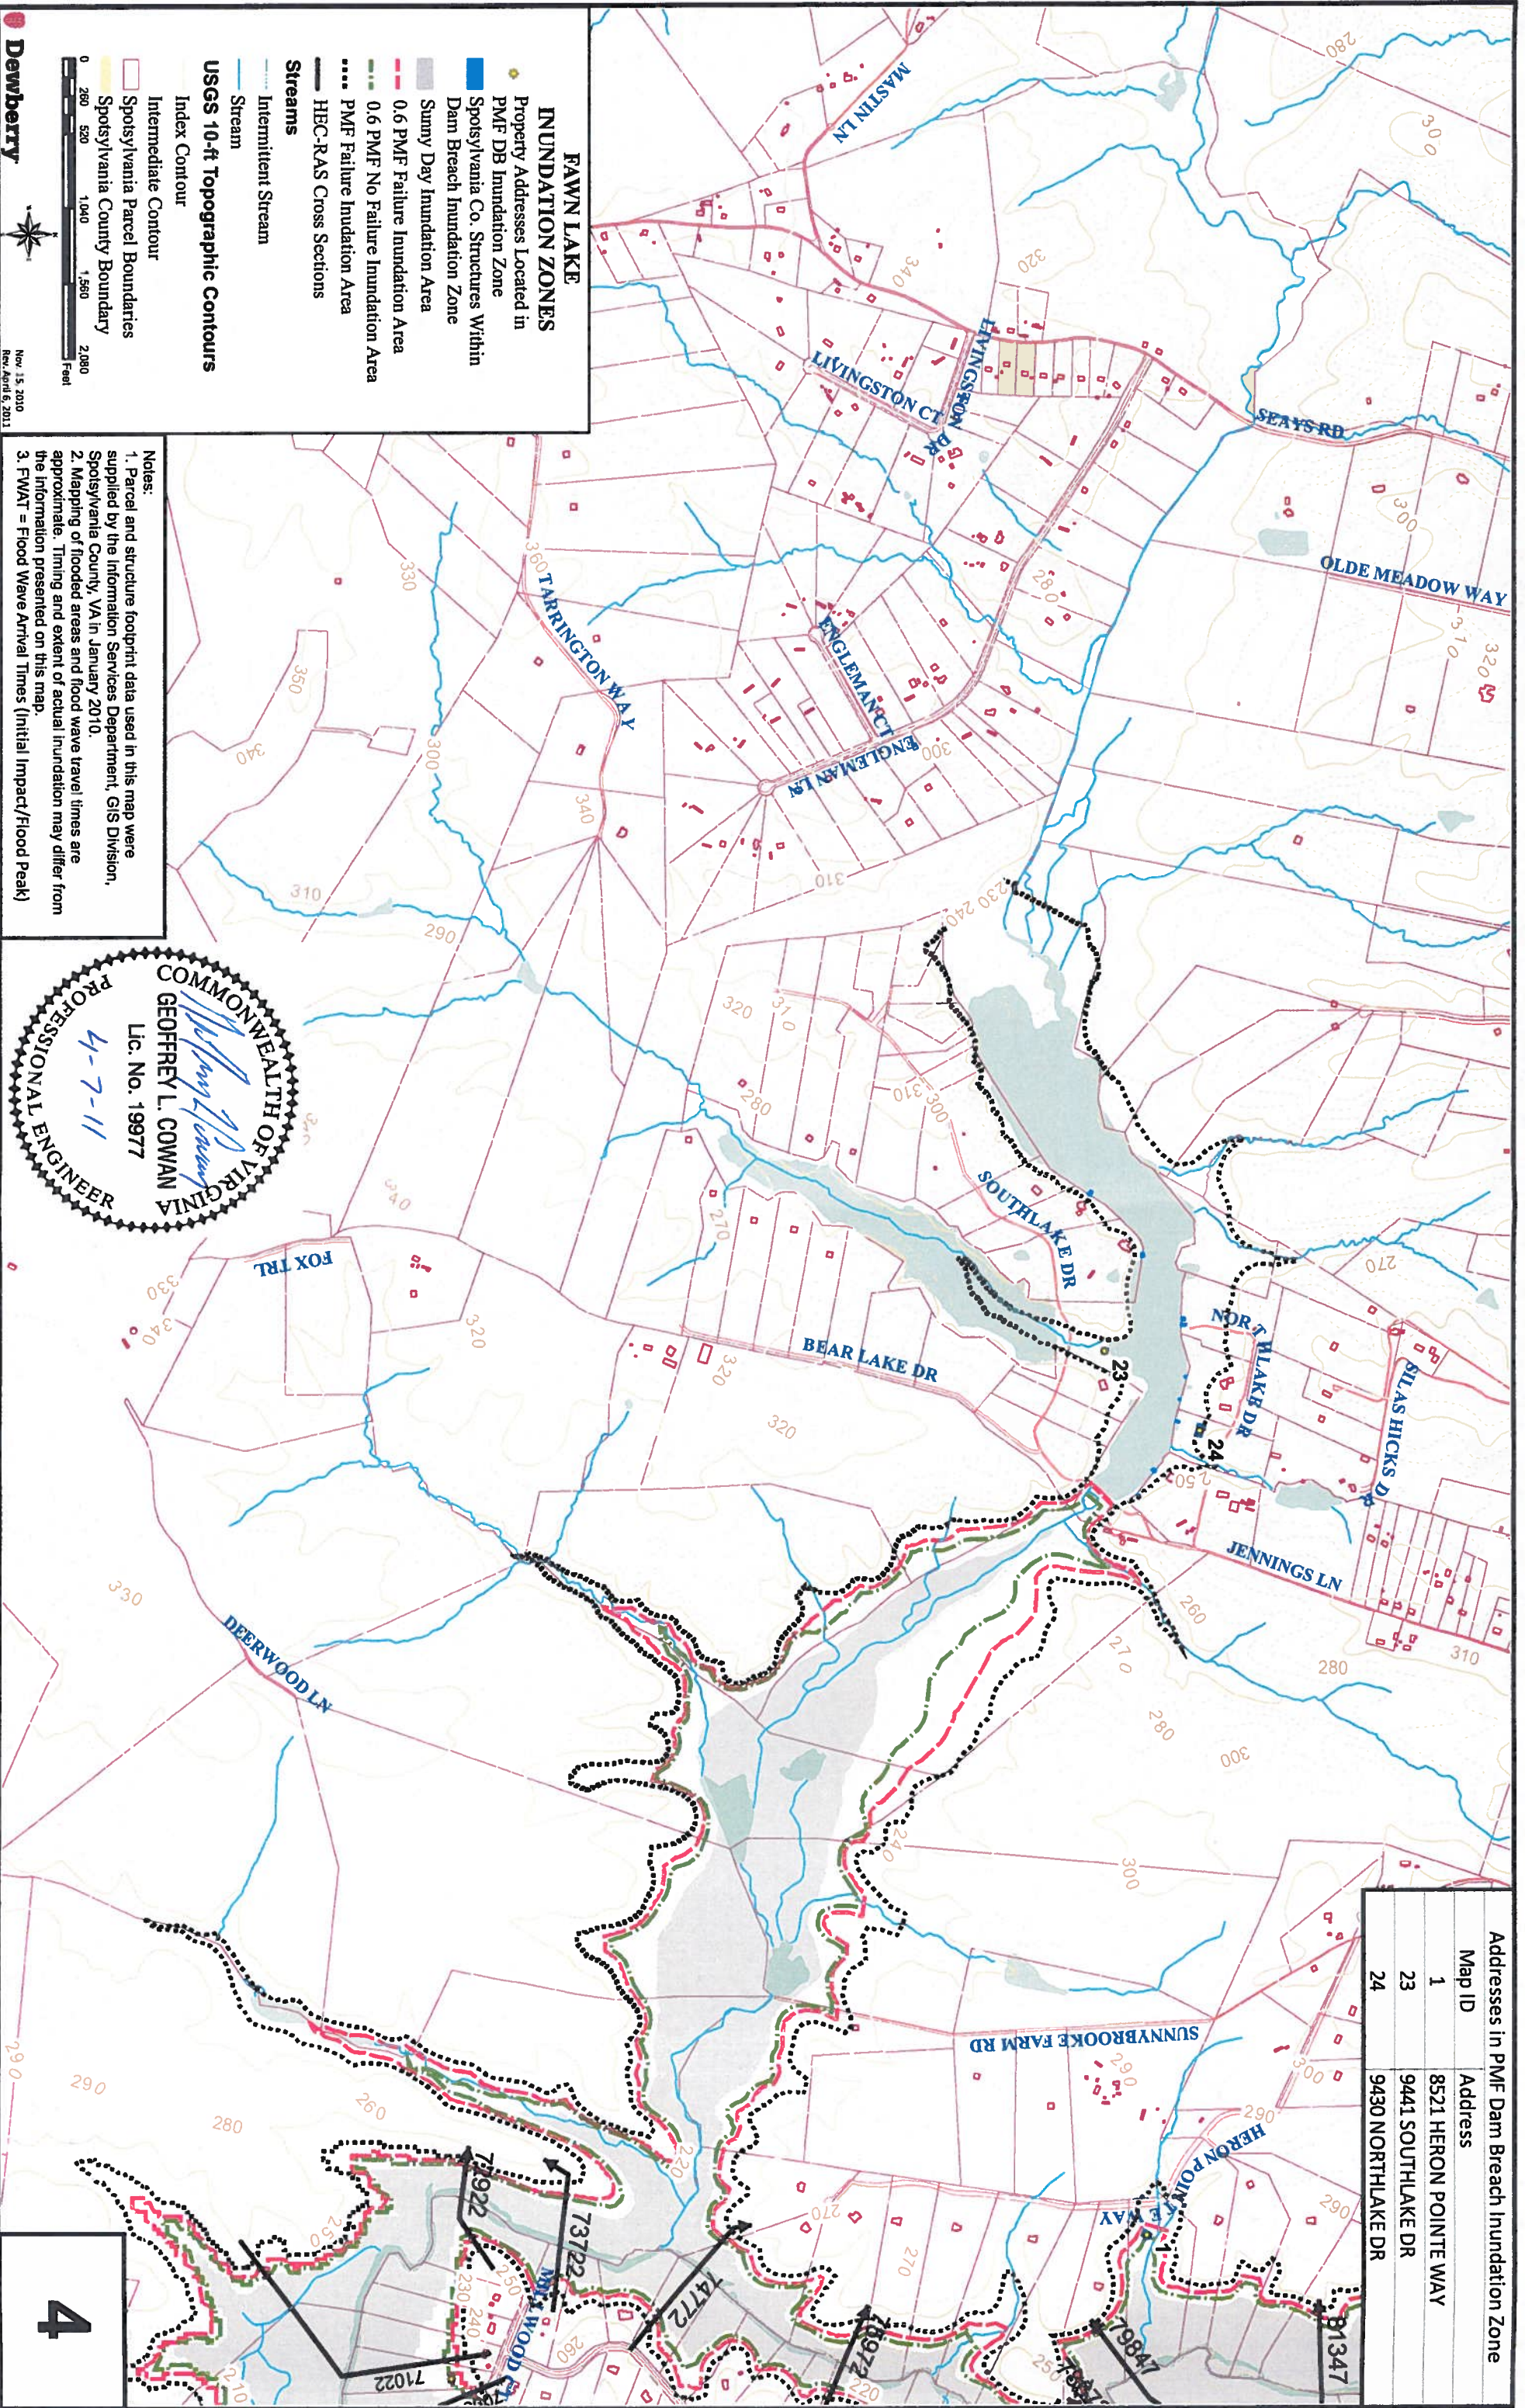
- Property Addresses Located in PMF DB Inundation Zone
- Spotsylvania Co. Structures Within Dam Breach Inundation Zone
- Sunny Day Inundation Area
- 0.6 PMF Failure Inundation Area
- 0.6 PMF No Failure Inundation Area
- PMF Failure Inundation Area
- HEC-RAS Cross Sections

1. Parcel and structure footprint data used in this map were supplied by the Information Services Department, GIS Division, Spotsylvania County, VA in January 2010.
2. Mapping of flooded areas and flood wave travel times are approximate. Timing and extent of actual inundation may differ from the information presented on this map.
3. FWAT = Flood Wave Arrival Times (Initial Impact/Flood Peak)
